**SURFACE FRICTION STUDY OF ARIZONA HIGHWAYS**  
**FINAL REPORT**

1. Report No.  Report No. 3	2. Government Accession No.	3. Recipient's Catalog No.	
4. Title and Subtitle  SURFACE FRICTION STUDY OF ARIZONA HIGHWAYS		5. Report Date  July 1972

6. Performing Organization Code	
7. Author(s) John C. Burns Rowan J. Peters		8. Performing Organization Report No.	
9. Performing Organization Name and Address  Materials Division (Research) 1745 West Madison Phoenix, Arizona 85007		10. Work Unit No.

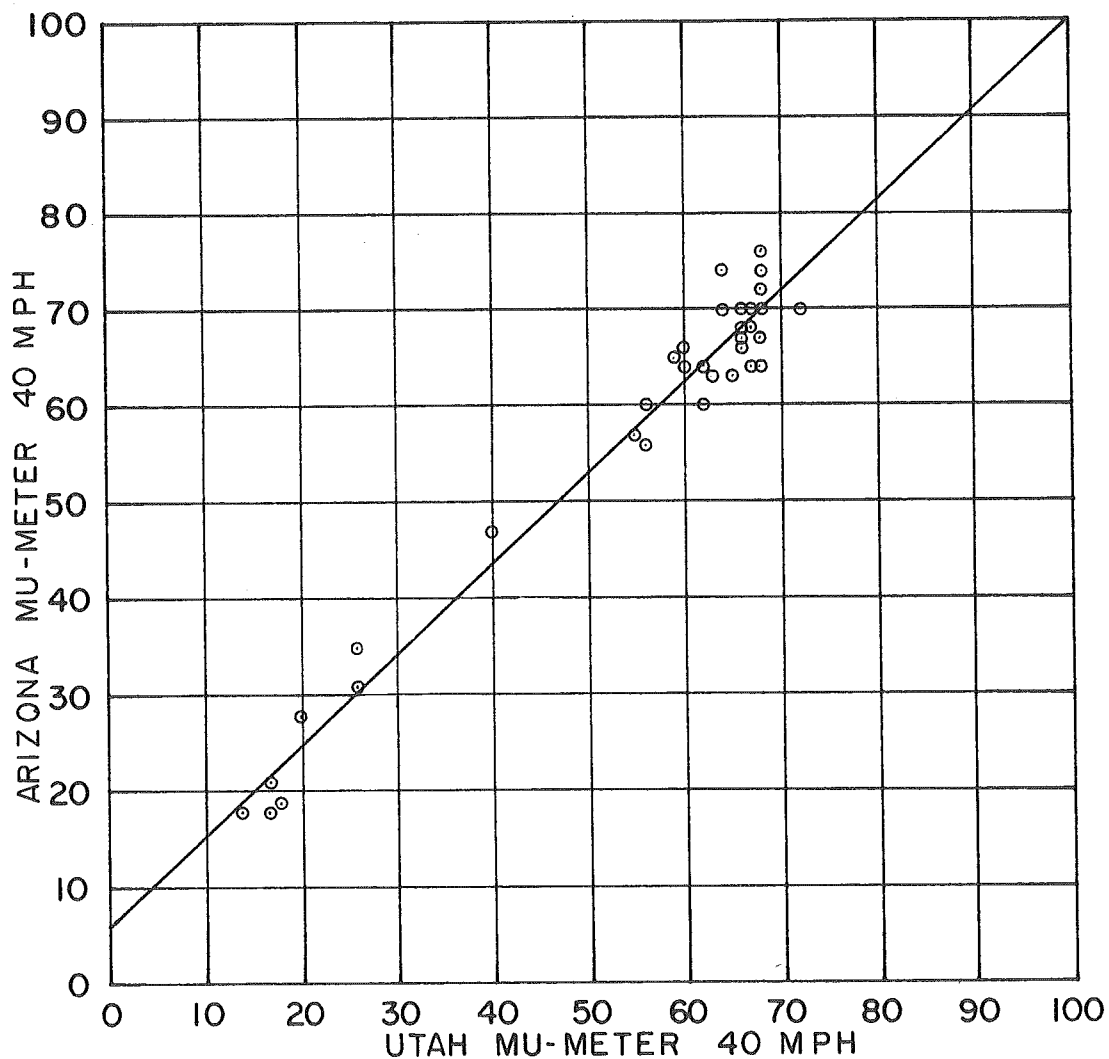
Figure 22

UTAH MU-METER CORRELATION  
NOV. 17, 1969

Number of cases = 34  
 Arizona =  $5.923 + 0.9430 (\text{Utah})$   
 Utah =  $-6.281 + 1.0605 (\text{Arizona})$   
 Correlation coefficient = 0.9820  
 Standard error = 3.45 Az values

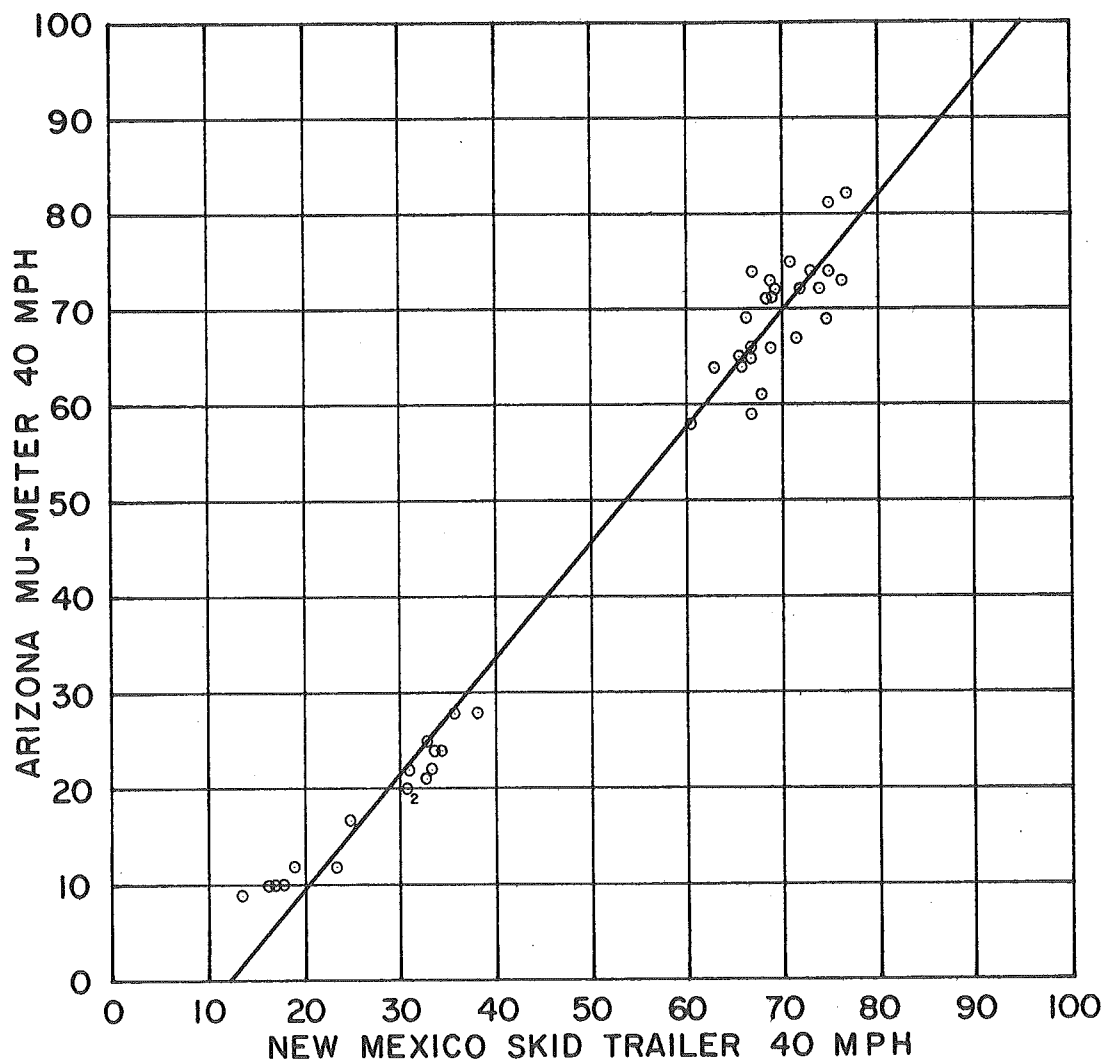
Figure 23

NEW MEXICO SKID TRAILER CORRELATION  
SEPTEMBER 14, 1971

Number of cases = 42

Mu-Meter =  $-14.939 + 1.2105(\text{Skid Trailer})$

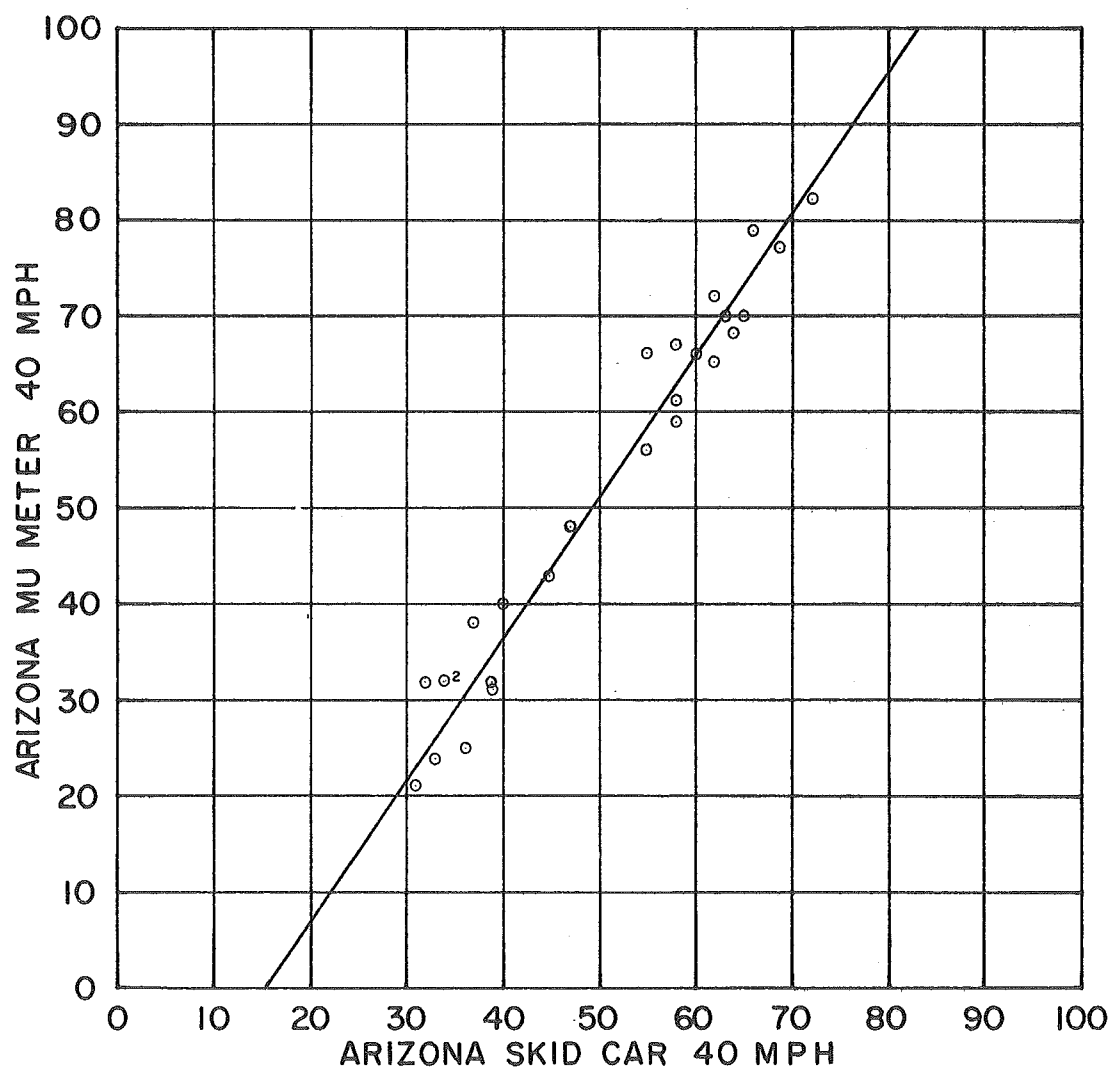
Figure 24

SKID CAR CORRELATION  
JANURARY 1972

Number of cases = 26

Skid Car =  $15.219 + 0.6777(\text{Mu-Meter})$ Mu Meter =  $-22.456 + 1.4755(\text{Skid Car})$

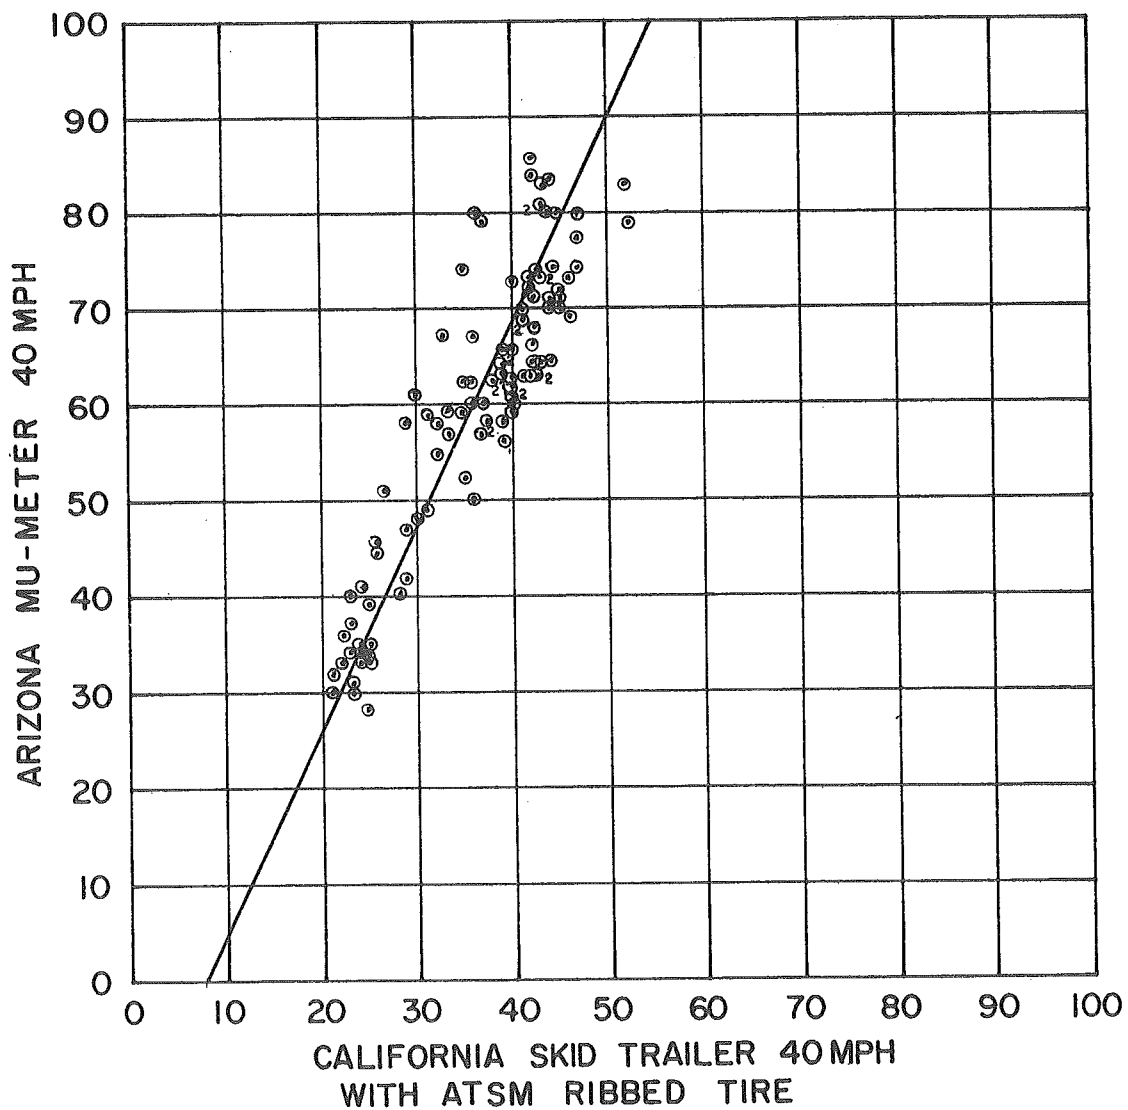
Figure 25

CALIFORNIA SKID TRAILER CORRELATION  
MARCH, 1972

NUMBER OF CASES = 111  
 MU-METER =  $-17.829 + 2.1416(\text{Calif})$   
 CALIF. =  $8.325 + 0.4669(\text{Mu-Meter})$   
 CORRELATION COEFFICIENT = 0.9172  
 STANDARD ERROR = 3.21 Calif values

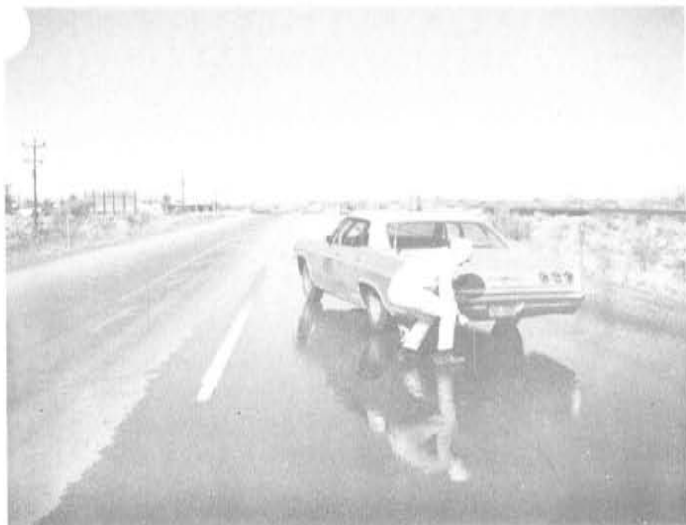
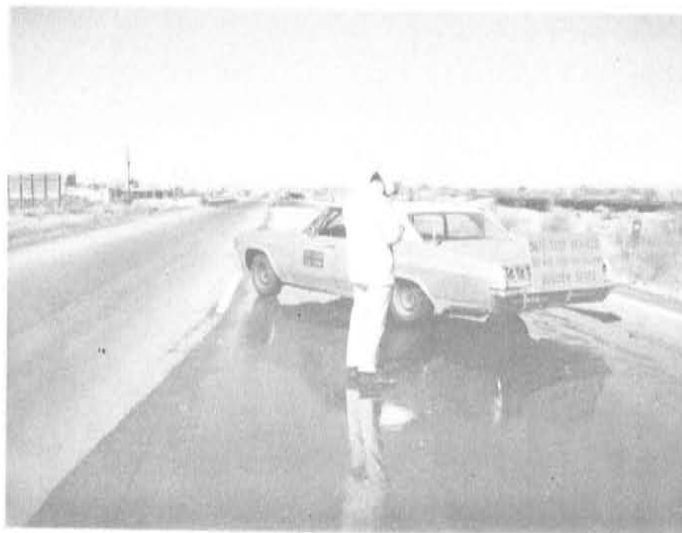
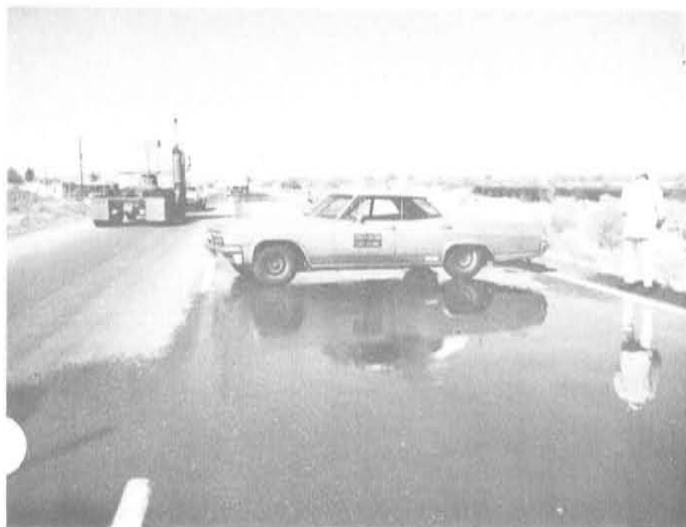
Figure 35

RIGHT WHEEL PATH = SDN  $\begin{matrix} 40 & 50 \\ & \searrow \end{matrix}$  17%  
 LEFT WHEEL PATH = SDN  $\begin{matrix} 49 & 60 \\ & \searrow \end{matrix}$  Difference

← (A) Car skids at 30 MPH and rotates 25° counterclockwise

→ (B) Car skids at 40 MPH and rotates 40° clockwise

← (C) Car skids at 50 MPH and rotates 95° counterclockwise

During our testing, a condition was noted that we feel warrants special attention and further investigation. The condition occurs when the two wheelpaths in which a vehicle rides have a different coefficient of friction. We are aware that there will usually be a small difference, but this is not the condition we are describing. The differential wheelpath friction (DWPF) we are considering is one in which a vehicle may be riding on two different surface types, two different ribbons of asphaltic concrete or concrete pavement, or a condition where one wheelpath is flushed or polished while the other is not. To our surprise, a very small difference in the wheelpath frictions will cause a car to spin out of control when braking. An example of two conditions are shown in Figures 35 and 36. In Figure 35, the wet stopping distance number at 40 MPH ( $SDN_{40}$ ) was 50 for the right wheelpath and 60 for the left wheelpath, which is only a 17 percent difference. In picture A, the car skidded at 30 MPH and rotated  $25^{\circ}$  counterclockwise. In picture B, the car skidded at 40 MPH and rotated  $40^{\circ}$  counterclockwise. In picture C, the car skidded at 50 MPH and rotated  $95^{\circ}$  counterclockwise. When the direction of skidding was reversed, the same values were recorded with the

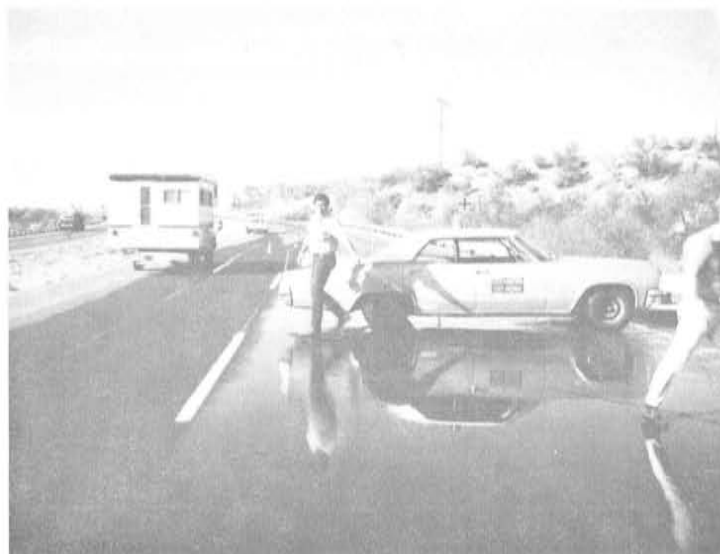
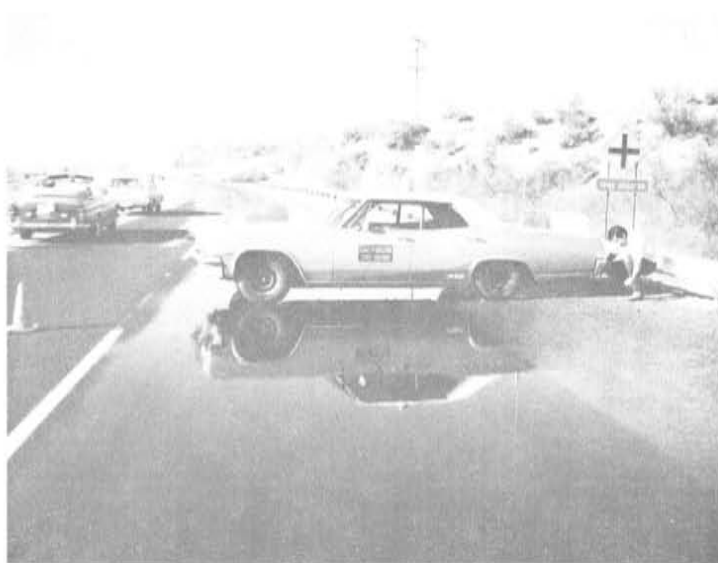
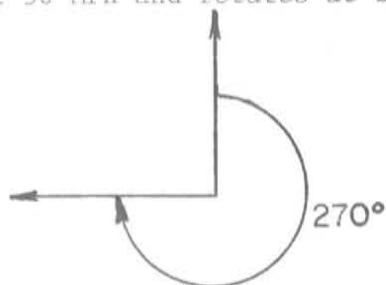
RIGHT WHEEL PATH = SDN  $\frac{67}{40}$   
 LEFT WHEEL PATH = SDN  $\frac{41}{40}$  } 39% Difference

(A)  
 Car skids at 40 MPH and rotates 90° clockwise

(B)  
 Car skids at 50 MPH and rotates at 270° clockwise

Figure 36 is an extreme case used to portray what might happen if one wheelpath were flushing while the other was not. However, the first case is one that is fairly common and, although both wheelpaths have a satisfactory level of friction, a hazardous condition occurs due to their difference. As the speed increases, the effects increase dramatically. Under such conditions, the normal driver tends to remove his foot from the brake as he begins to rotate. When he does, his car is propelled in the direction the vehicle is turned, perhaps off the road or into the oncoming traffic lane.

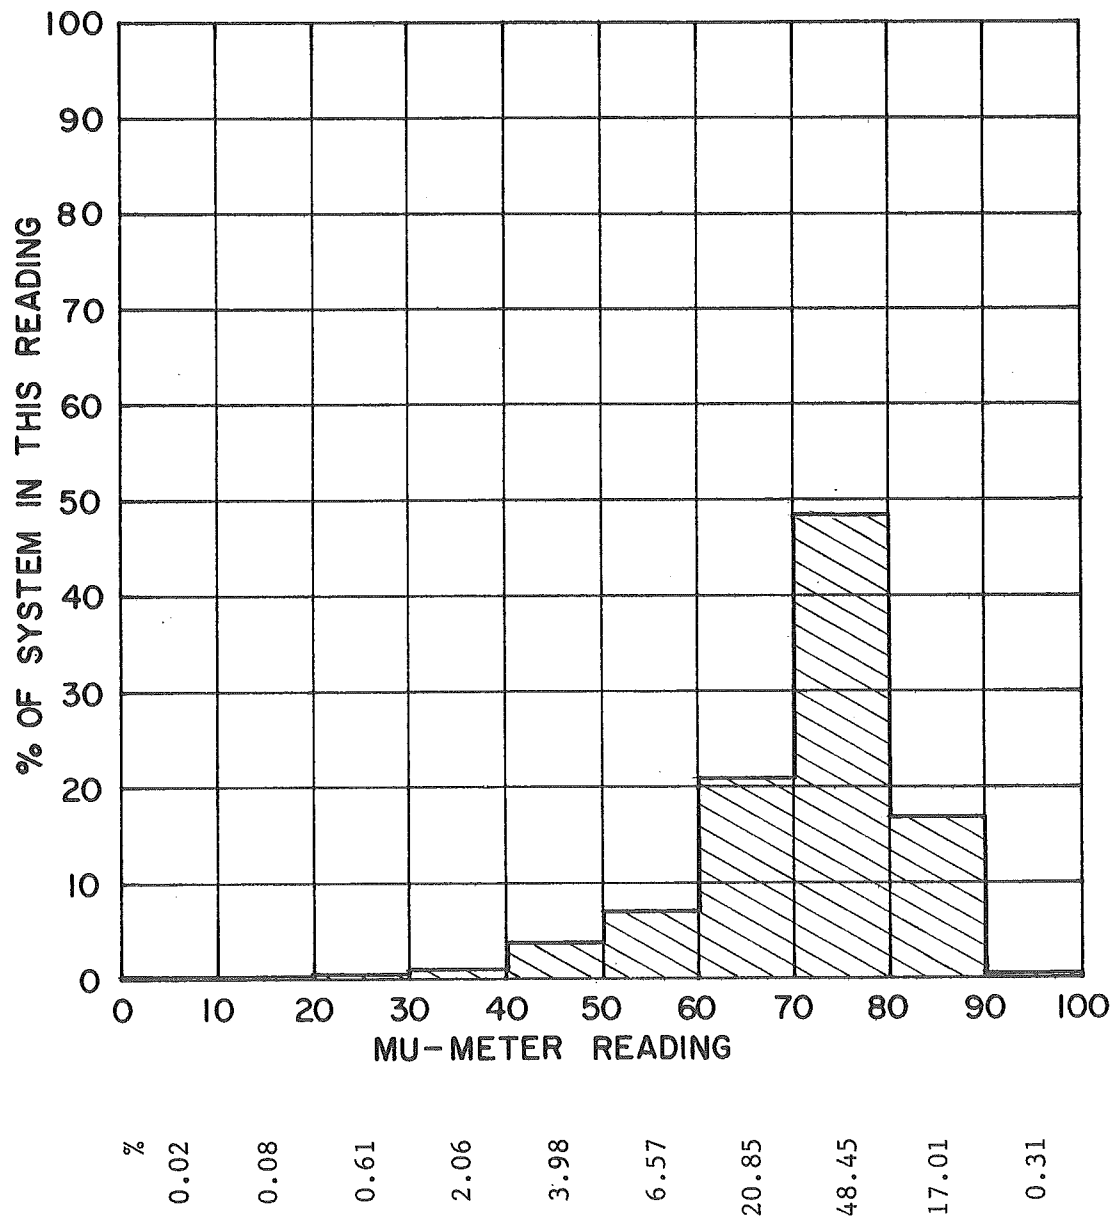
Figure 37

INTERSTATE, STATE AND U.S.  
HIGHWAYS IN ARIZONA

As part of the study, an analysis of the percent of the highway system falling into each friction range was made (Figure 37). These and following interpretations are made from the highway inventory previously mentioned. The results showed that only 2.8 percent of the Arizona highway system fell below a skid number of 40. This figure must be considered when evaluating the accident analysis. It was found that approximately 50 percent of the highway system fell within the Mu-Meter frictional range of 71 to 80. These results indicate that the skid resistance level of the Arizona highway system is predominantly very good and that the present pavement designs and aggregate types are producing satisfactory skid resistant surfaces.

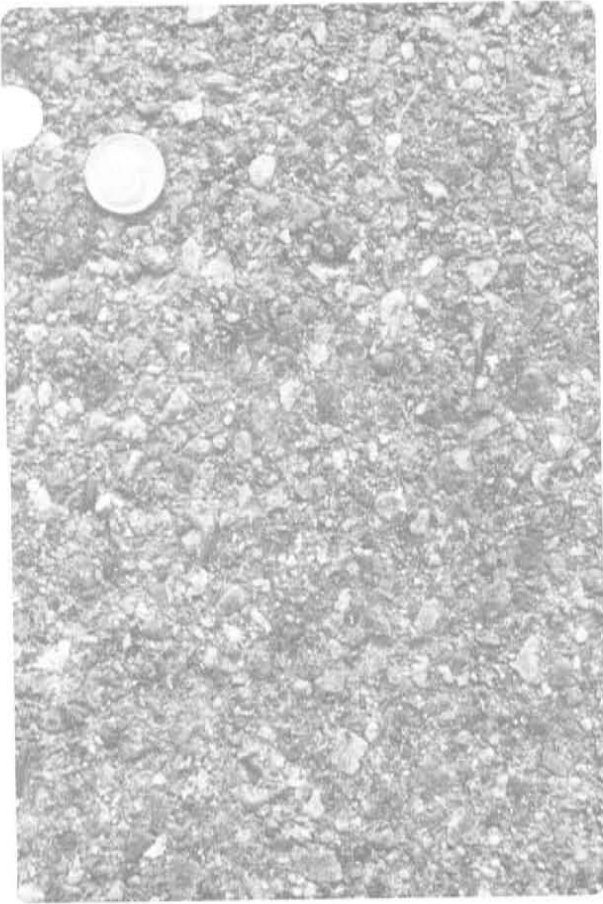
I-10-M.P. 175.2, N.B. INSIDE LANE

SURFACE - 3/8 INCH DENSE GRADED ASPHALTIC CONCRETE
